WATERDATA

Starflow Firmware Tests. Urban Stormwater Drain. 10/6/2008 to 8/7/2008.

1. Overview.

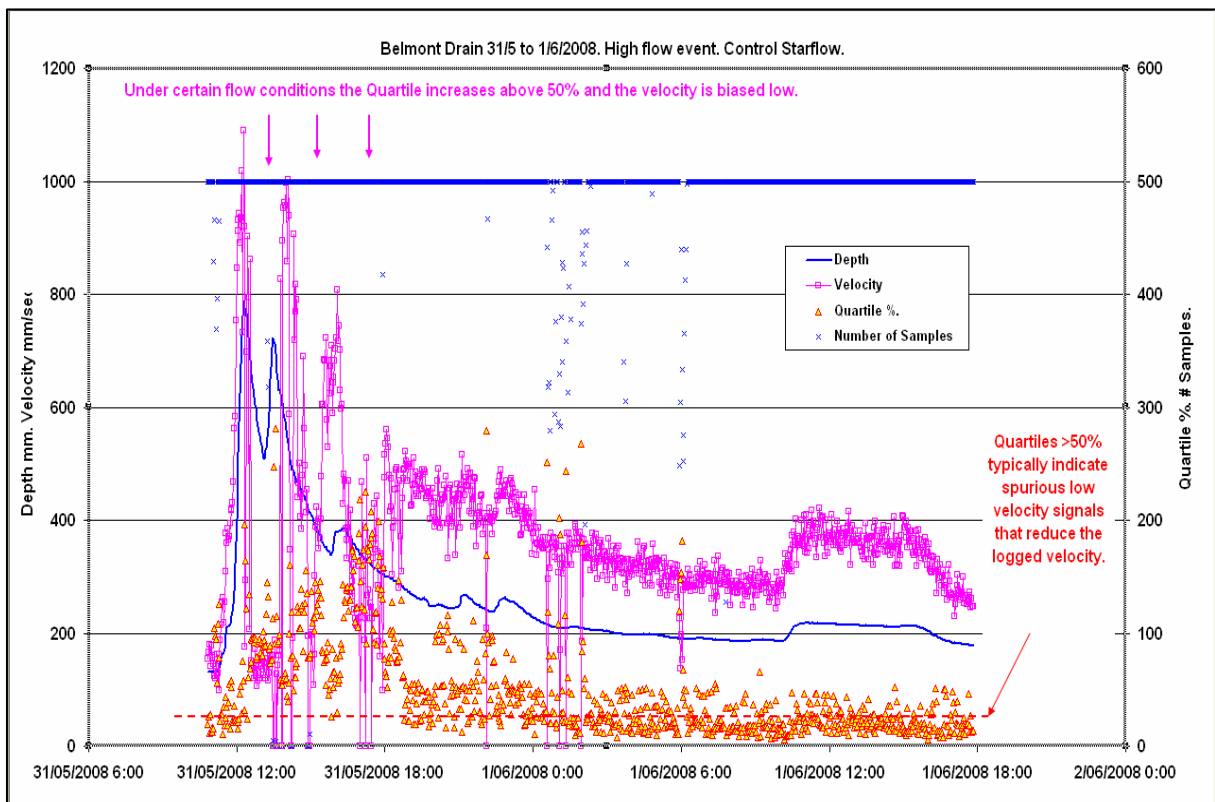
One significant problem was tendency of the instrument to under-register velocities during some flow conditions. This characteristic has also been noted at many other sites.

The following plot shows the details of a typical high flow event where the velocity data sometimes fails to record correctly. The data shown is the logged depth and velocity measured each 5-minutes. The signal details from each acoustic velocity measurement are also shown.

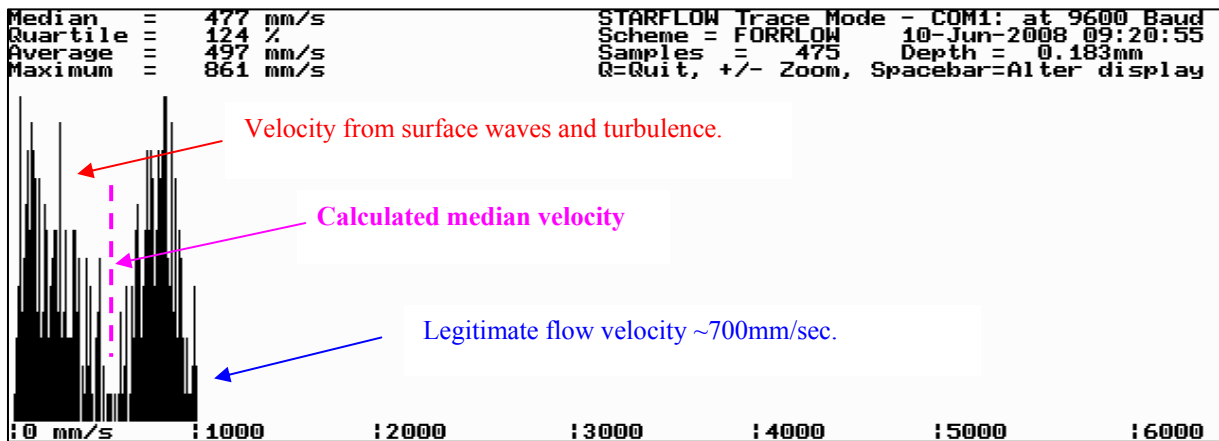
Waterdata tests at a range of sites identified that the cause of the reduced velocity was the Starflow detecting the boundary velocities from surface wave conditions and bed turbulence, as well as from the actual water velocity. These boundary conditions are acoustically reflective and can be over-represented in the measured signal spectrum. When this happens the calculated median velocity is biased low.

The following plot shows a typical “Velocity Test” screen where the acoustic signals detected from each measuring scan can be displayed. The Starflow is clearly measuring two different groups of velocity signals. The logged median velocity is calculated as lying between these groups. However the slower “velocities” are not representative of the water velocity.

This problem has been recognised at a range of other sites. A proposed solution was to modify the velocity processing within the Starflow firmware, to provide the option to remove these slow velocities from the median velocity calculation. As part of this calculation the signal spread is calculated as the “quartile”. Good velocity measurements typically have quartiles <50%. The processing was modified to allow a target quartile to be specified. Slow velocities are progressively excluded from the median calculation until the desired quartile is reached.

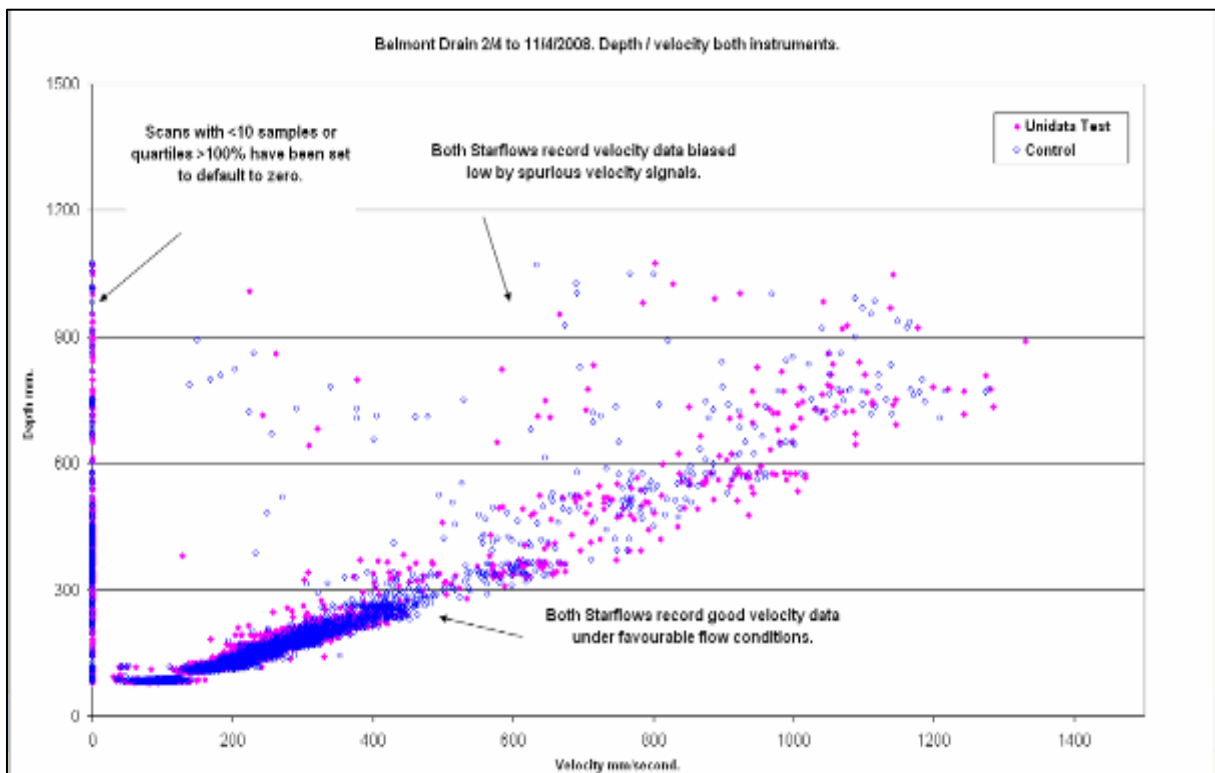
Data from 5/3/2008 to 10/6/2008 indicated both instruments were measuring similar velocity data under various flow conditions. The following plot compares the depth / velocity relationship for data points logged by the two instruments at the same time, during a typical period. Deeper analysis confirms both record similar results.

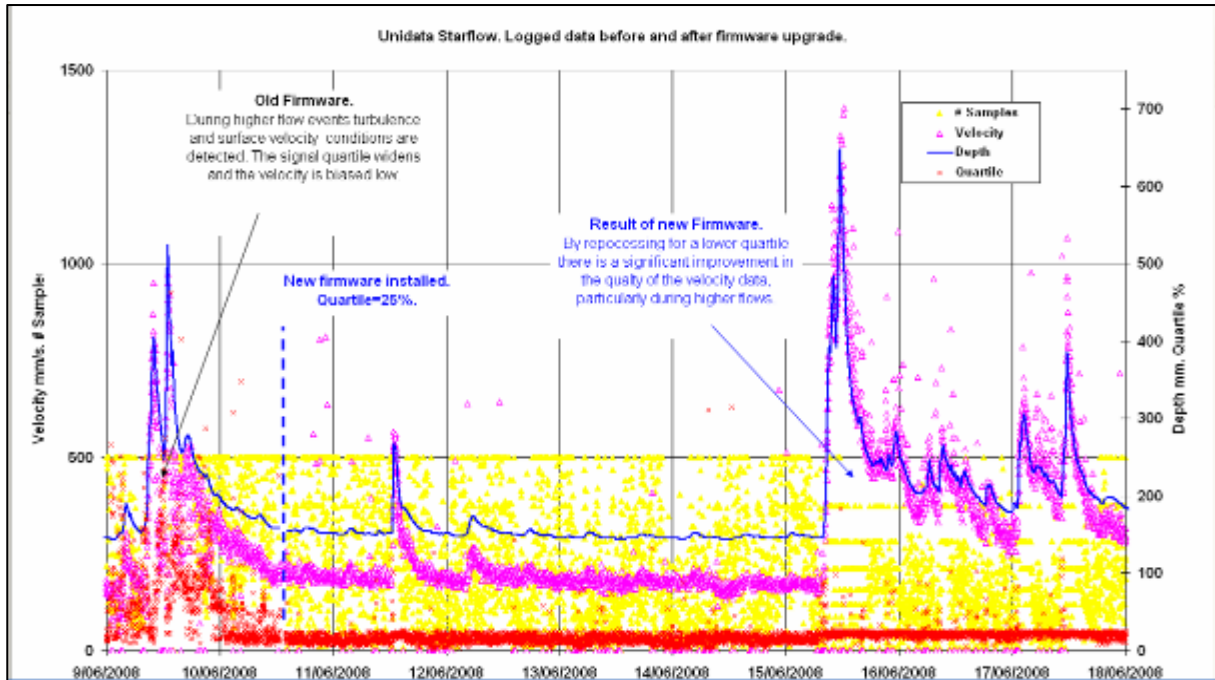
On 10/6/2008 the firmware of the test instrument was upgraded to the modified version. The following plot shows the immediate improvement of the quality of the velocity data.

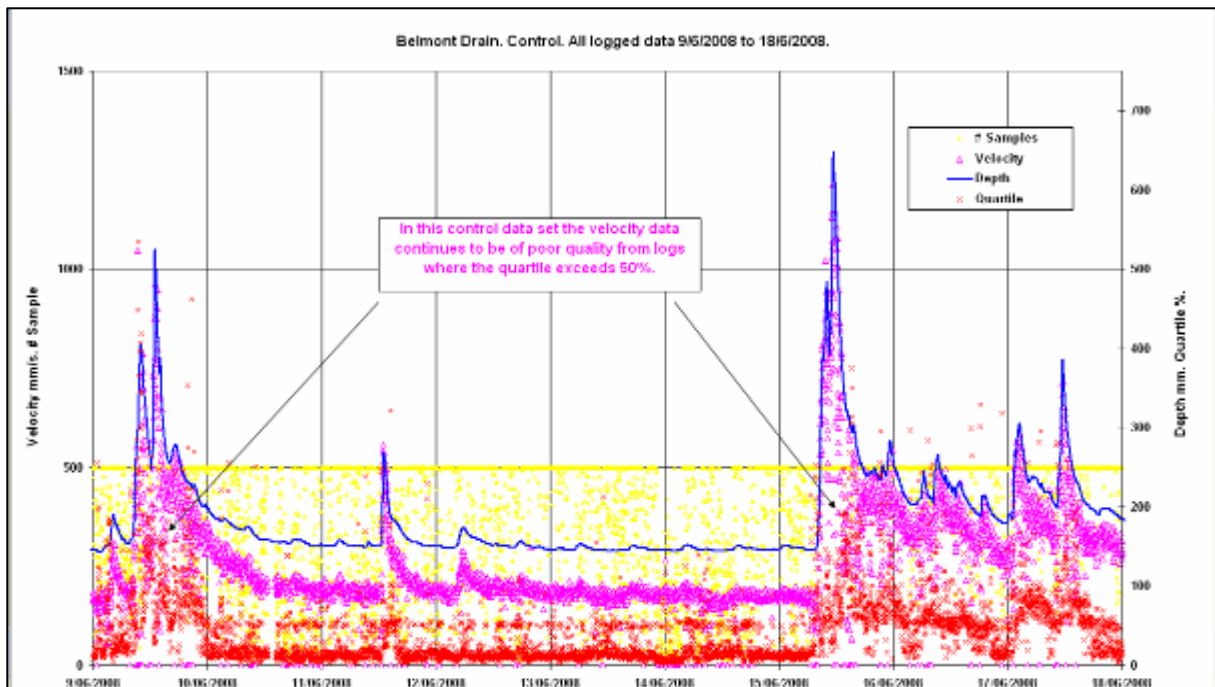
This compares with the continued poor quality of some velocity data logged by the control Starflow, shown on the following plot. The new firmware has significantly improved the quality of all, and particularly the higher velocity data.

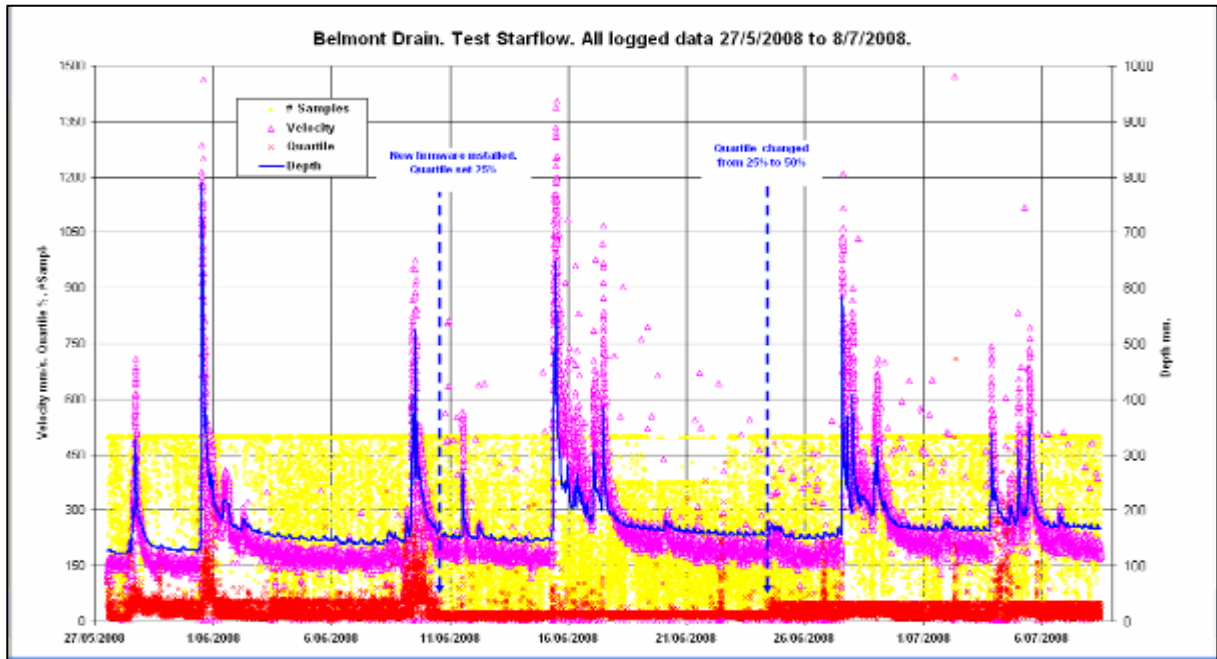
During the initial tests the target quartile for the new firmware was set to 25% from 10/6 to 24/6. It was noted that this resulted in some spurious high velocity data being logged. The target quartile was changed to 50% for the period from 24/6 to 8/7. These changes are shown in the following plot of all data for the period.

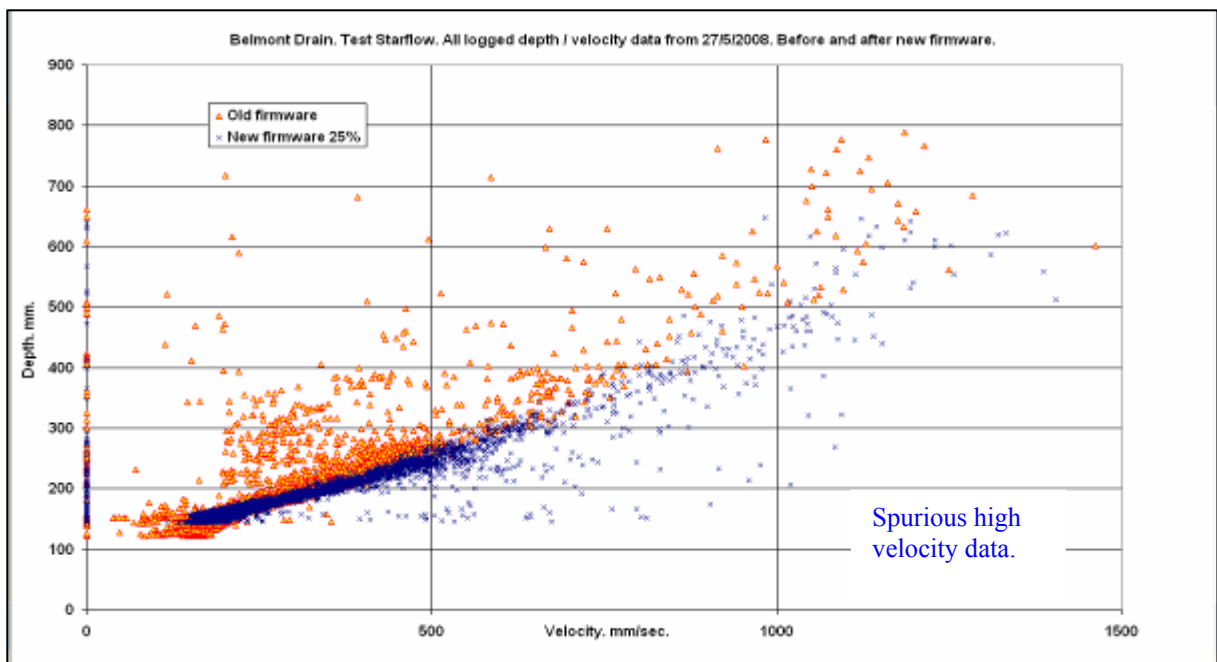
The following plot compares the depth / velocity relationship of data points with the old and new firmware to 24/6. Using the 25% quartile setting the new firmware generates some scattered and spurious high velocity data. This occurs when the algorithm is focussed too far onto the high velocity end of the signal spectrum.

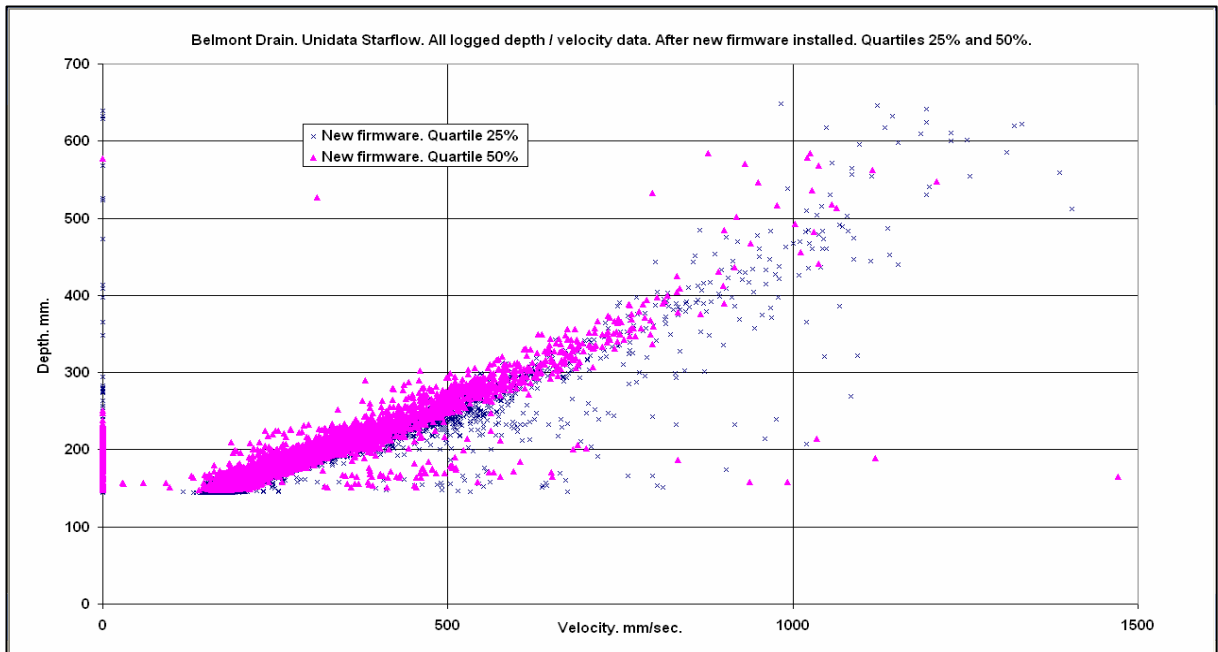
On 24/6/2008 the quartile was adjusted to 50%. The following plot shows the depth / velocity relationship of the data recorded with both the 25% and 50% quartile. The 50% quartile setting generally reduced the scattered high velocity spiking, except for a period where a debris blockage at low flow caused some signal distortion.

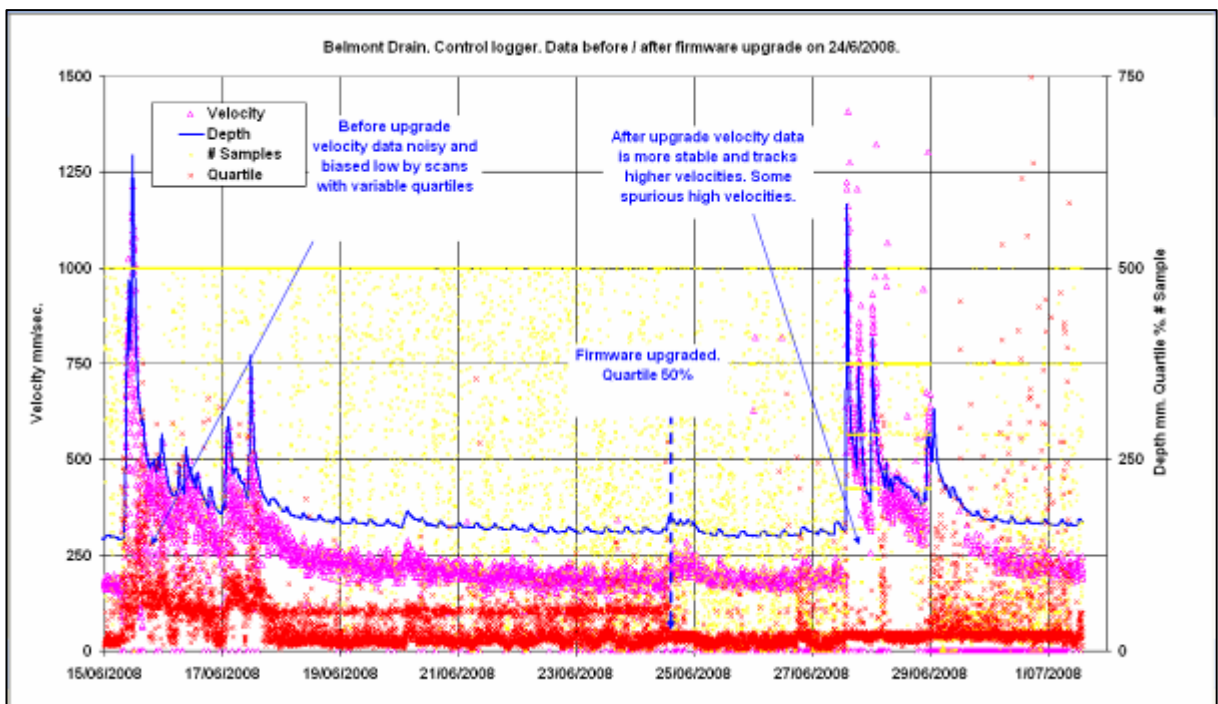
The control logger was upgraded to the new firmware on 24/6/2008. The following plot shows the effect on the velocity data was a significant improvement of the quality of all velocity data, and particularly of higher velocities.

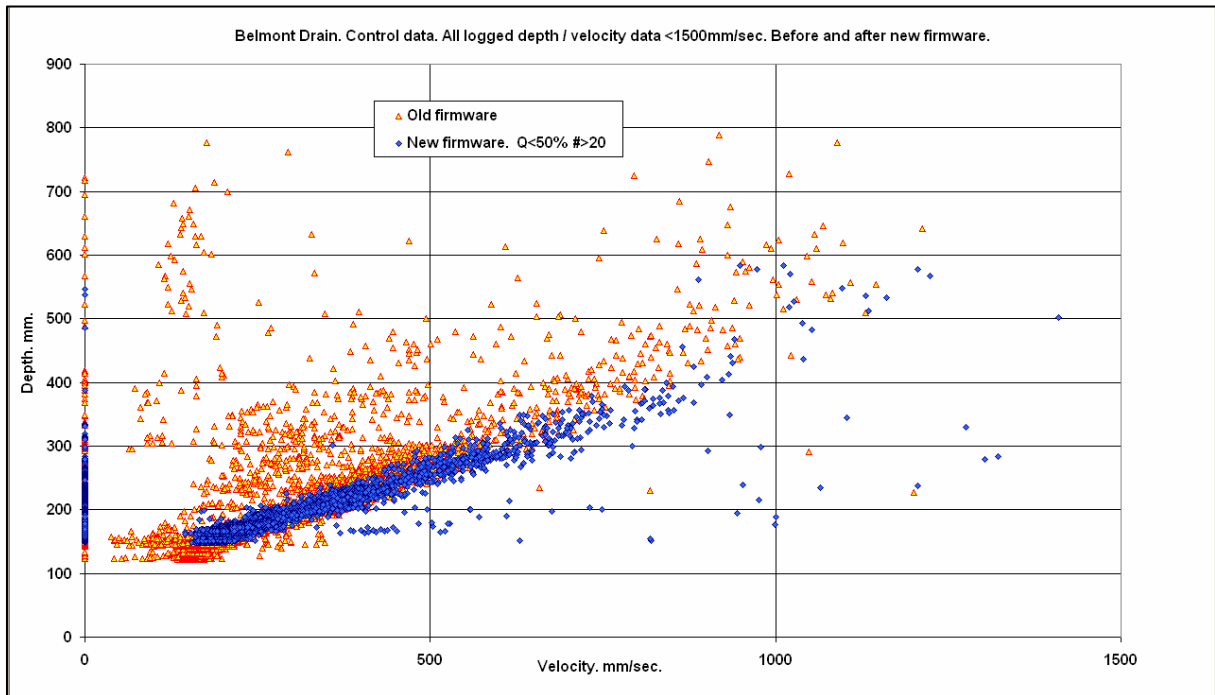
The following plot of all data from the control logger the shows the relationship between depth and velocity, before and after the firmware upgrade. The new firmware significantly improves the integrity of the velocity within the normal velocity range of the site.

Waterdata recommends that the new firmware should be used at all sites to overcome the deficiencies of the present instrument under some velocity conditions.
